Water Pump Replacement Caution for 1998-2003 Chrysler 2.7L VIN R, U & V Engines

The AERA Technical Committee offers the following information regarding water pump replacement for 1998-2003 Chrysler 2.7L VIN R, U & V engines. According to Chrysler engine warranty administrators many water pumps for these engines have been replaced needlessly.

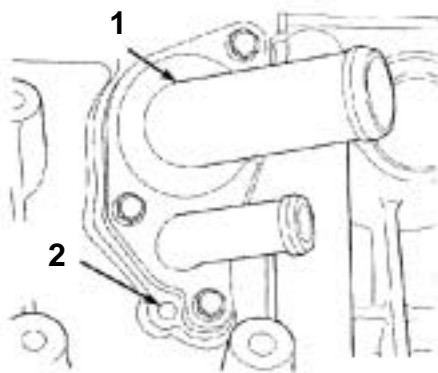
Figure 1 - Water Pump Weep Passage

These replaced pumps were replaced as the result of visual observation of traces of a thin black stain running down the pump weep passage as shown in Figure 1. According to Chrysler a slight amount of stain below the water pump weep hole/passage is considered normal operation. Replace the pump only if a heavy deposit or a steady flow of engine coolant is evident from the weep passage. Of course, also replace the pump if it shows bearing damage or cracking.

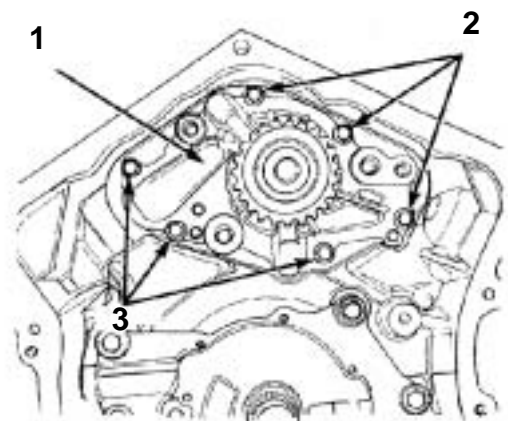
Figure 2 - Internal Water Pump Location

The water pump for this engine is an internal design as shown in Figure 2. Currently, five hours of labor time is allowed for pump replacement. Technicians may be confronted with an additional complaint after a replacement pump is installed if it is observed to weep. It is advised to carefully monitor and confirm coolant level loss before replacing the water pump for this engine.
