## Engine Ticking Sound On 1998-99 GM 5.7L VIN R Engines

The AERA Technical Committee offers the following information regarding an engine ticking sound on 1998-99 GM 5.7L VIN R engines. This noise may be described as similar to valve train noise or detonation and most noticeable when the engine is completely warmed up and driven under a load.

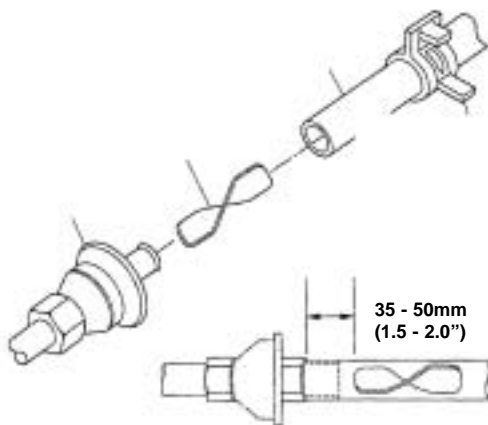
**Figure 1 - Baffle**

The noise may be due to an exhaust pressure wave that is migrating past the secondary A.I.R check valves into the hose plumbing. The pressure wave produces an objectionable noise similar to valve train noise or detonation.

To cure this problem, GM offers a baffle under Part #12562714 as shown in Figure 1. To successfully fix this problem, three of the baffles will be required. These locations are in Figure 2. These baffles are installed into the A.I.R hoses and should be 1.5" - 2.0" from the end of the hose.
