Revised Cam Sprocket & Sensor For 2001-2005 GM 8.1L VIN G & E Engines

The AERA Technical Committee offers the following information regarding a revised cam sprocket sensor for 2001-2005 GM 8.1L VIN G & E engines. Depending on the year of vehicle manufacture, there are two distinct sprockets and sensors used for these engines.

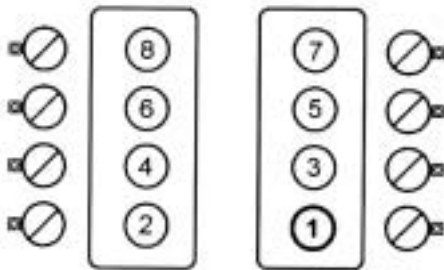
Front of Vehicle

Firing Order: 1-8-4-3-6-5-7-2
