Cracked Or Broken Flexplate On 1990-1996 Ford 4.0L VIN X Engines

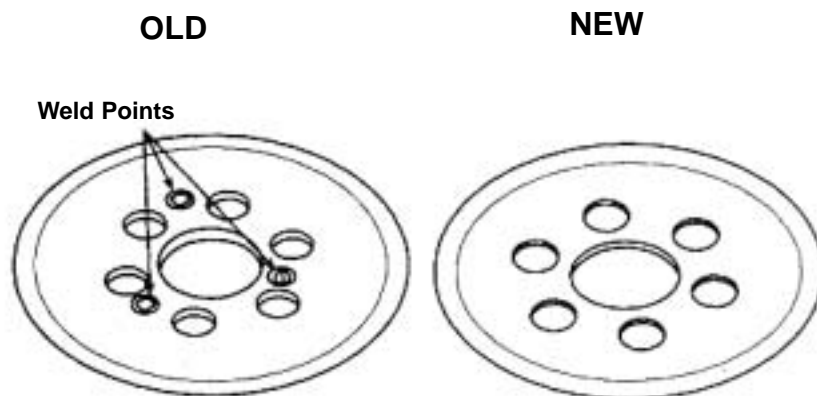
The AERA Technical Committee offers the following information on cracked or broken flexplates on 1990-1996 Ford 4.0L VIN X engines. It has been reported that some vehicles equipped with an automatic transmission may exhibit an unusual noise or vibration during cranking. This condition may be caused by a cracked flexplate.

Old (Left) and New (Right) Flexplate Designs

To help reduce the possibility of this type of failure, Ford has redesigned the flexplate and offers it for replacement with Part number F1TZ-6375-BA. The revised flywheel has increased strength in the area where cracking is most common as shown below.
