Engine Coolant Leaks on 2000-02 Nissan 3.3L VG33E Engines

The AERA Technical Committee offers the following information regarding an engine coolant leak on 2000-02 3.3L VG33E engines. Customers may complain of engine coolant under the vehicle if sitting for a period of time or the smell of coolant when the engine is warm.

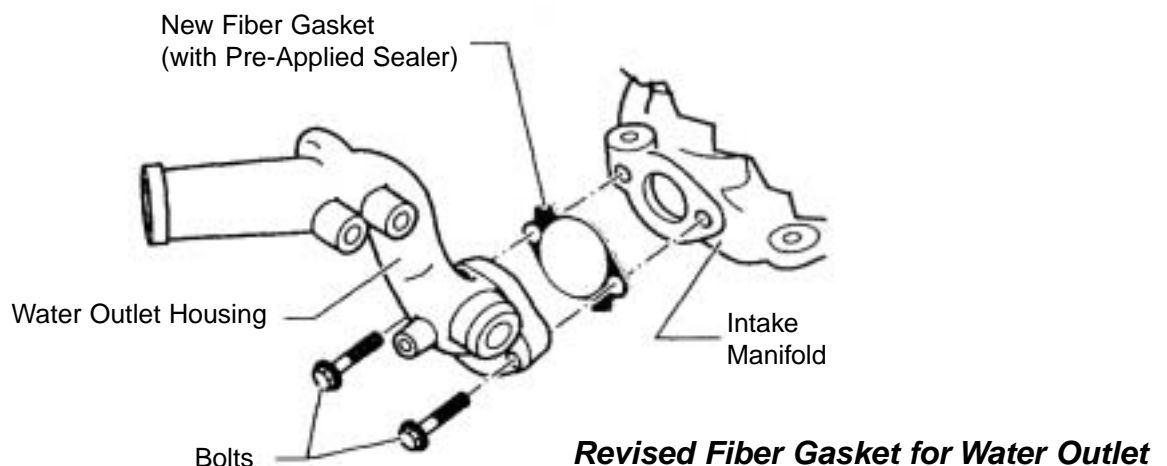
A leak between the intake manifold and the water outlet housing as shown below may cause this condition. Visually inspecting this area could verify that this is the source of the leak.

To rectify this problem, Nissan offers a revised fiber gasket, Part #11062-9Z000, to be installed between the water outlet and the intake manifold. When changing this gasket, make sure that you have drained the coolant just below the level of the water outlet. This will keep coolant from spilling when removing the housing.

Clean the sealing surface of the water outlet housing and the intake manifold to get rid of any old sealer that may be present. Install the two mounting bolts through the outlet housing and then slide the fiber gasket over the bolts until it is flush with the sealing surface of the housing.

Once the housing is installed onto the intake manifold, tighten the mounting bolts to a torque of 12-15 ft/lbs. Refill the cooling system and run the vehicle to verify that there are no further coolant leaks.
